Chartham Paper opt for rodless tensioner

As part of their ongoing Making Paper Safely improvement programme, ArjoWiggins Chartham Paper have installed one of the new William Kenyon rodless cylinder rope tensioners.

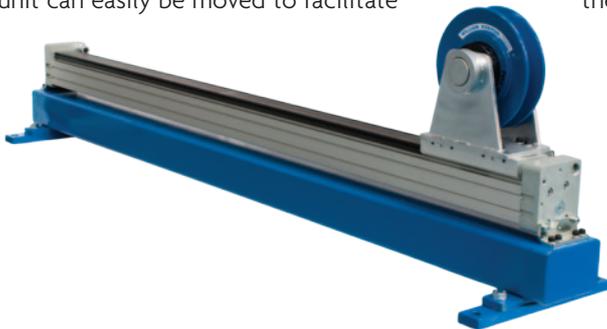
The installation is in the moisture section of their No.3 machine. The space saving design has allowed a position under the dryers to be utilised, which has made fitting of the ropes a much simpler and speedier operation.

The mill also designed their own unique addition to the tensioner by incorporating rails and wheels so the unit can easily be moved to facilitate

the fitting of the ropes without the necessity for operators to climb into the machine itself.

The pneumatic cylinders provide much more control over the rope tensions than the previous weighted versions, which helps to improve tail feeding and also potentially rope life.

The installation was undertaken by the mills engineering department and the electric and manual

controls were fitted in with the existing machine controls, rather than a bespoke panel being provided.
